GREENHILL PARK RESIDENTIAL SUBDIVISION

STAGE 17 and 18a Area LUK, Greenhill Park, Hamilton

GEOTECHNICAL COMPLETION REPORT ON SUBDIVISION EARTHWORKS AND RECOMMENDATIONS FOR BUILDING DEVELOPMENT

Our Ref: CR171738-S17&S18a-01 v3 (Contour Plan Update)

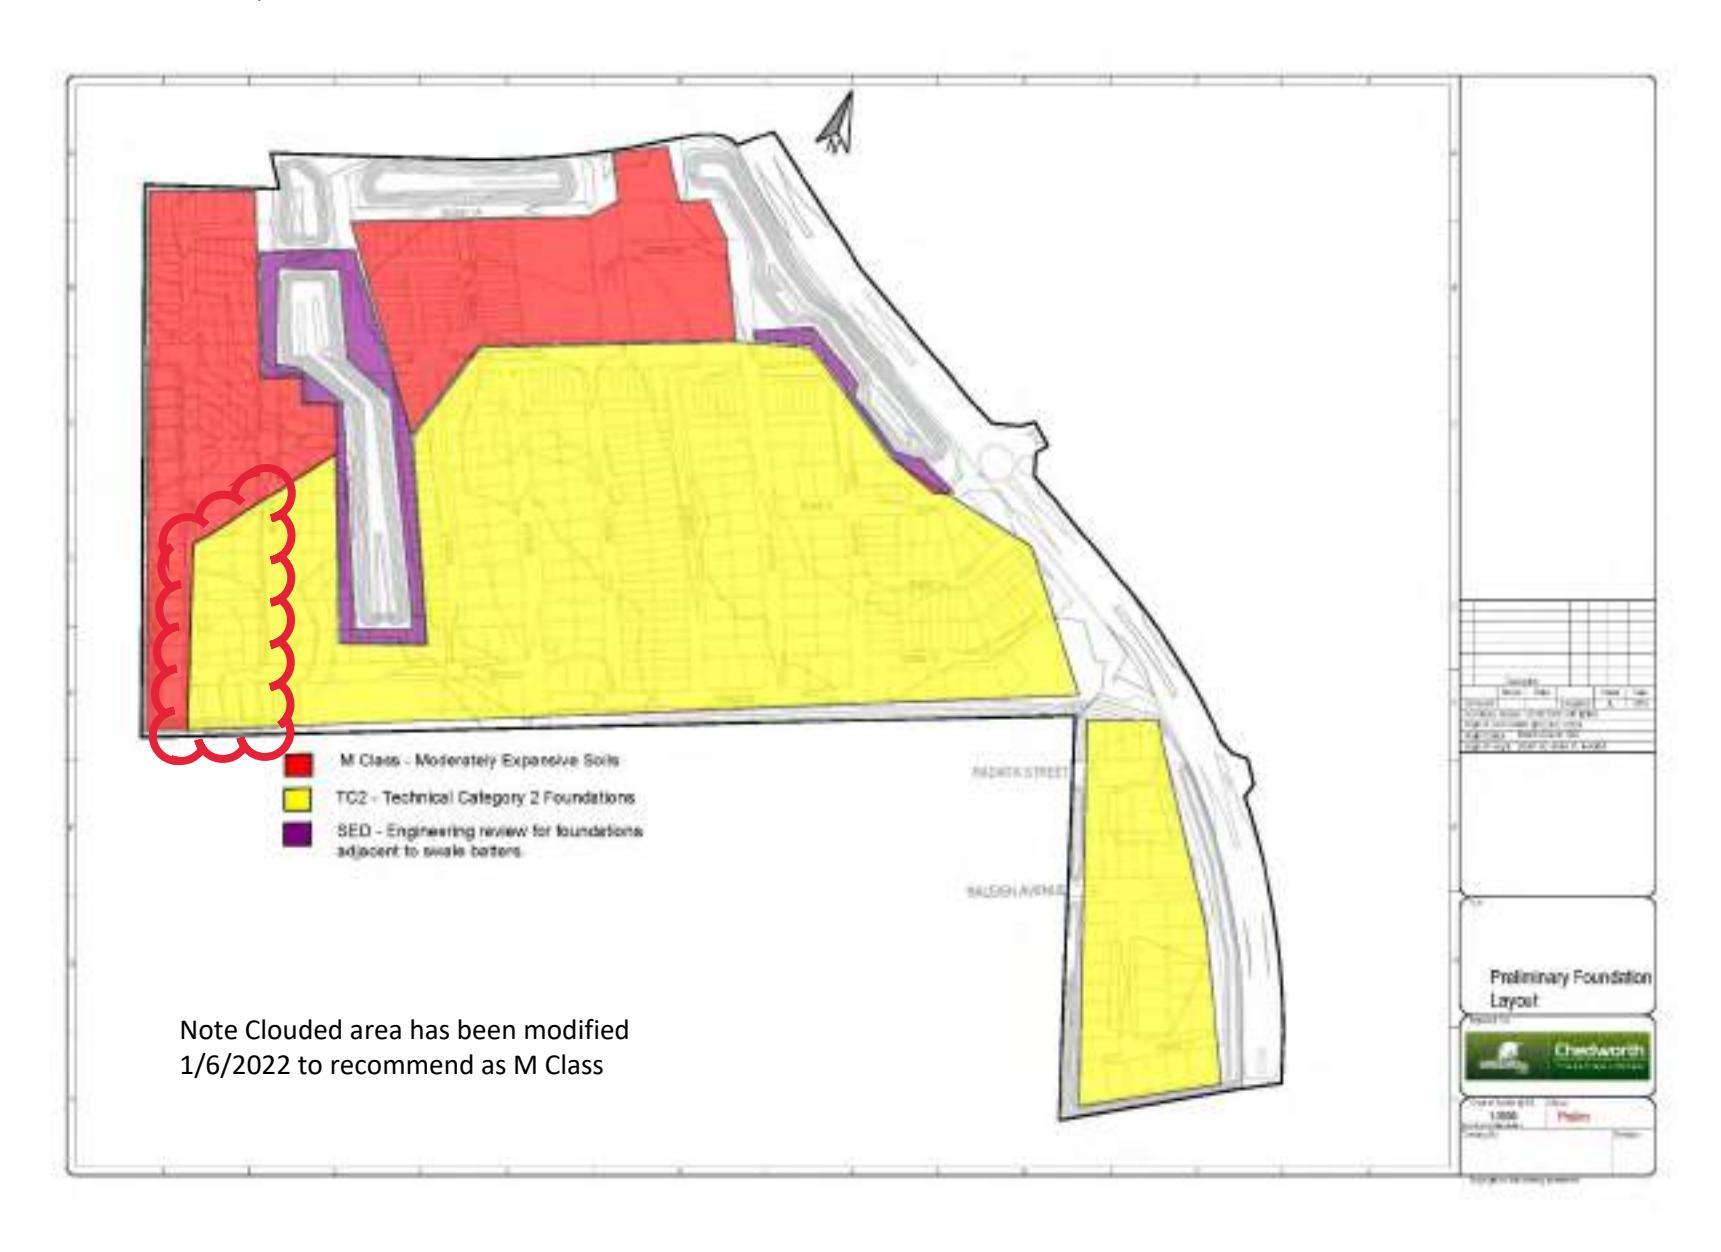
DBCE Preliminary Subdivision Foundation Plan

Foundations near the top of the swales are subject to Specific Engineering Designs. The liquefaction summary plan is appended to this Completion report (Appendix A). Specifically, the requirements are:

- 0m 1.5m no habitable dwellings to be built within 1.5 m of the swale crest.
- Lots adjacent to storm water swales to have specific engineered foundation designs, i.e., Lots 519 and 531.
