GREENHILL PARK RESIDENTIAL SUBDIVISION

STAGE 20 Area LUK, Greenhill Park, Hamilton

GEOTECHNICAL COMPLETION REPORT ON SUBDIVISION EARTHWORKS AND **RECOMMENDATIONS FOR BUILDING DEVELOPMENT**

Our Ref: CR171738-S20-GCR

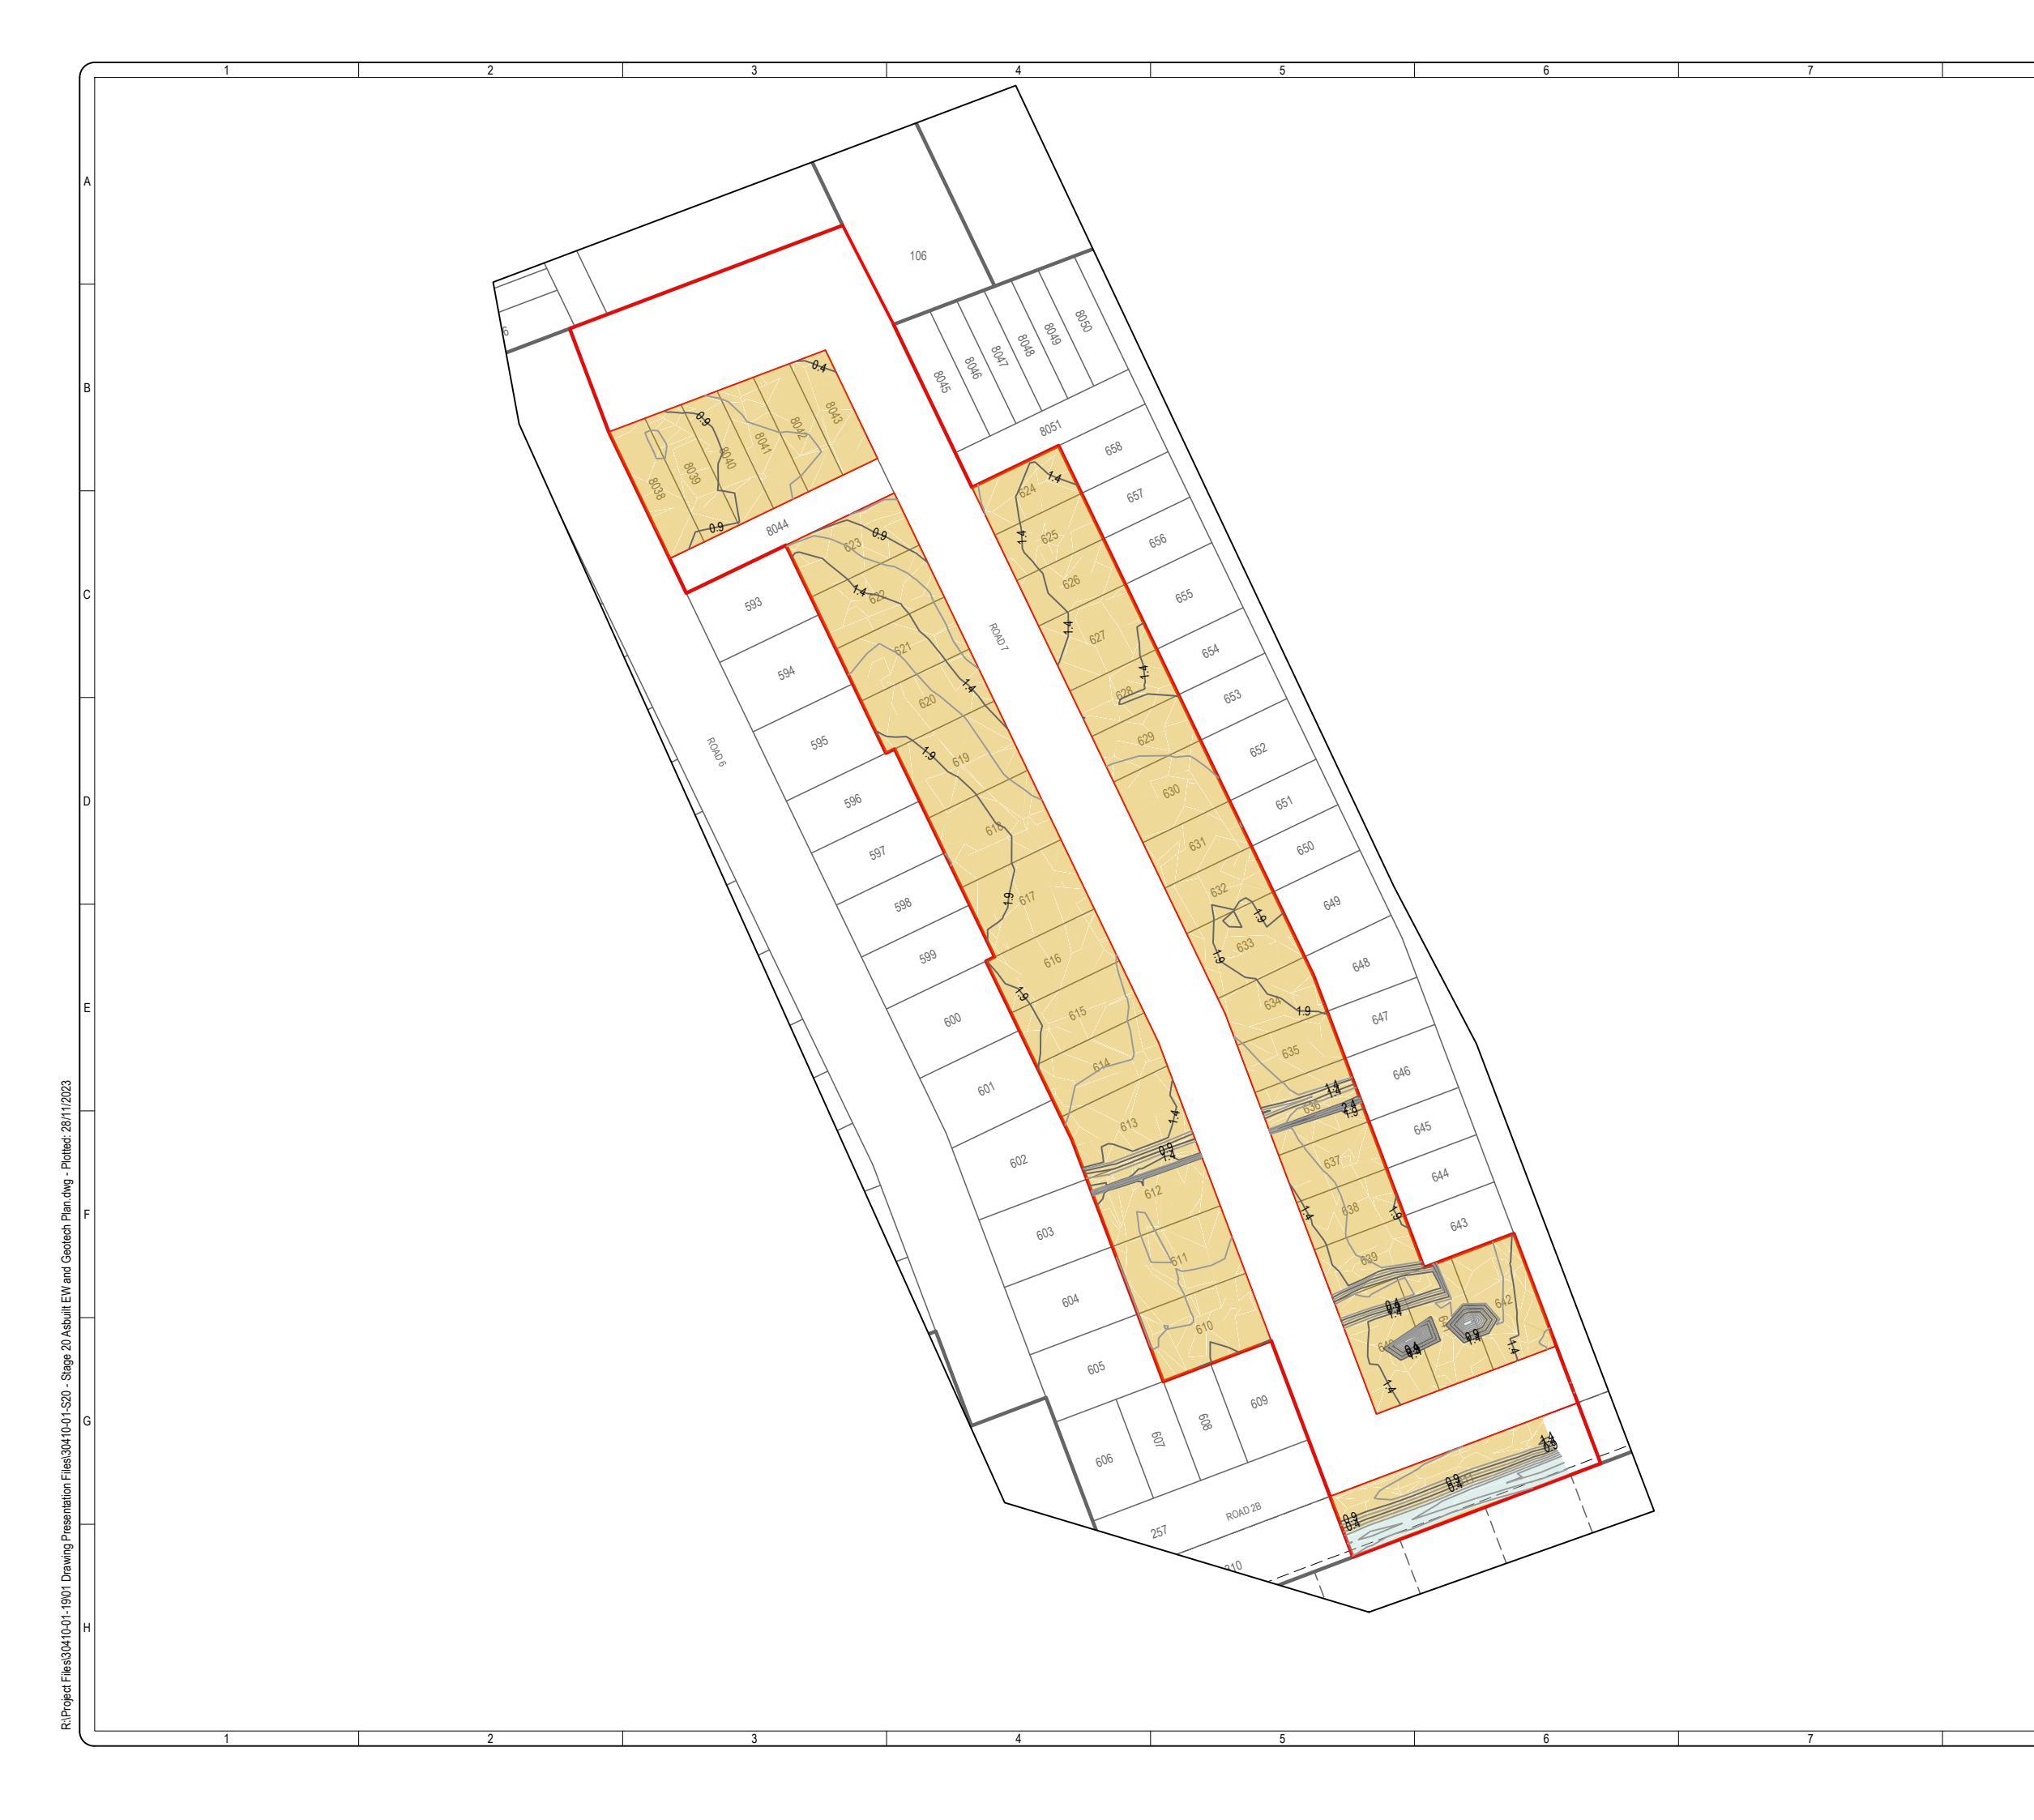
ÂN	A	S & L Land Specialists Ph. 07 577 6069 Emcil: info@silp.co.nz P.O. Box 231, Tauranga 3140 www.silp.co.nz
	в	Legend: Major Contour Minor Contour Cut Area Fill Area
	С	Contour Interval 0.25m
	D	
	E	
	F	Rev DESCRIPTION DRN CKD APP DATE 0 PRELIMINARY NP BP 13/11/23 AB1 AS-BUILT NP BP 13/11/23 AB2 Lot Level Update NP BP 27/11/23 AB2 Lot Level Update NP BP 27/11/23 AB2 NAME DATE NAME DATE SURVEYED DESIGNED DESIGNED DESIGNED COORDINATE SYSTEM: ORIGIN OF COORDINATES: HEIGHT DATUM: - -ORIGIN OF HEIGHT: TITLE TITLE -
	G	STAGE 20 CUT FILL PLAN ORIGINAL TO AS-BUILT
	H	PREPARED FOR

Areas partly developed by cut are shown on the cut fill plan (Appendix A). In these areas, the ground at formation levels was observed to comprise of Silty and Sandy Hinuera deposits.

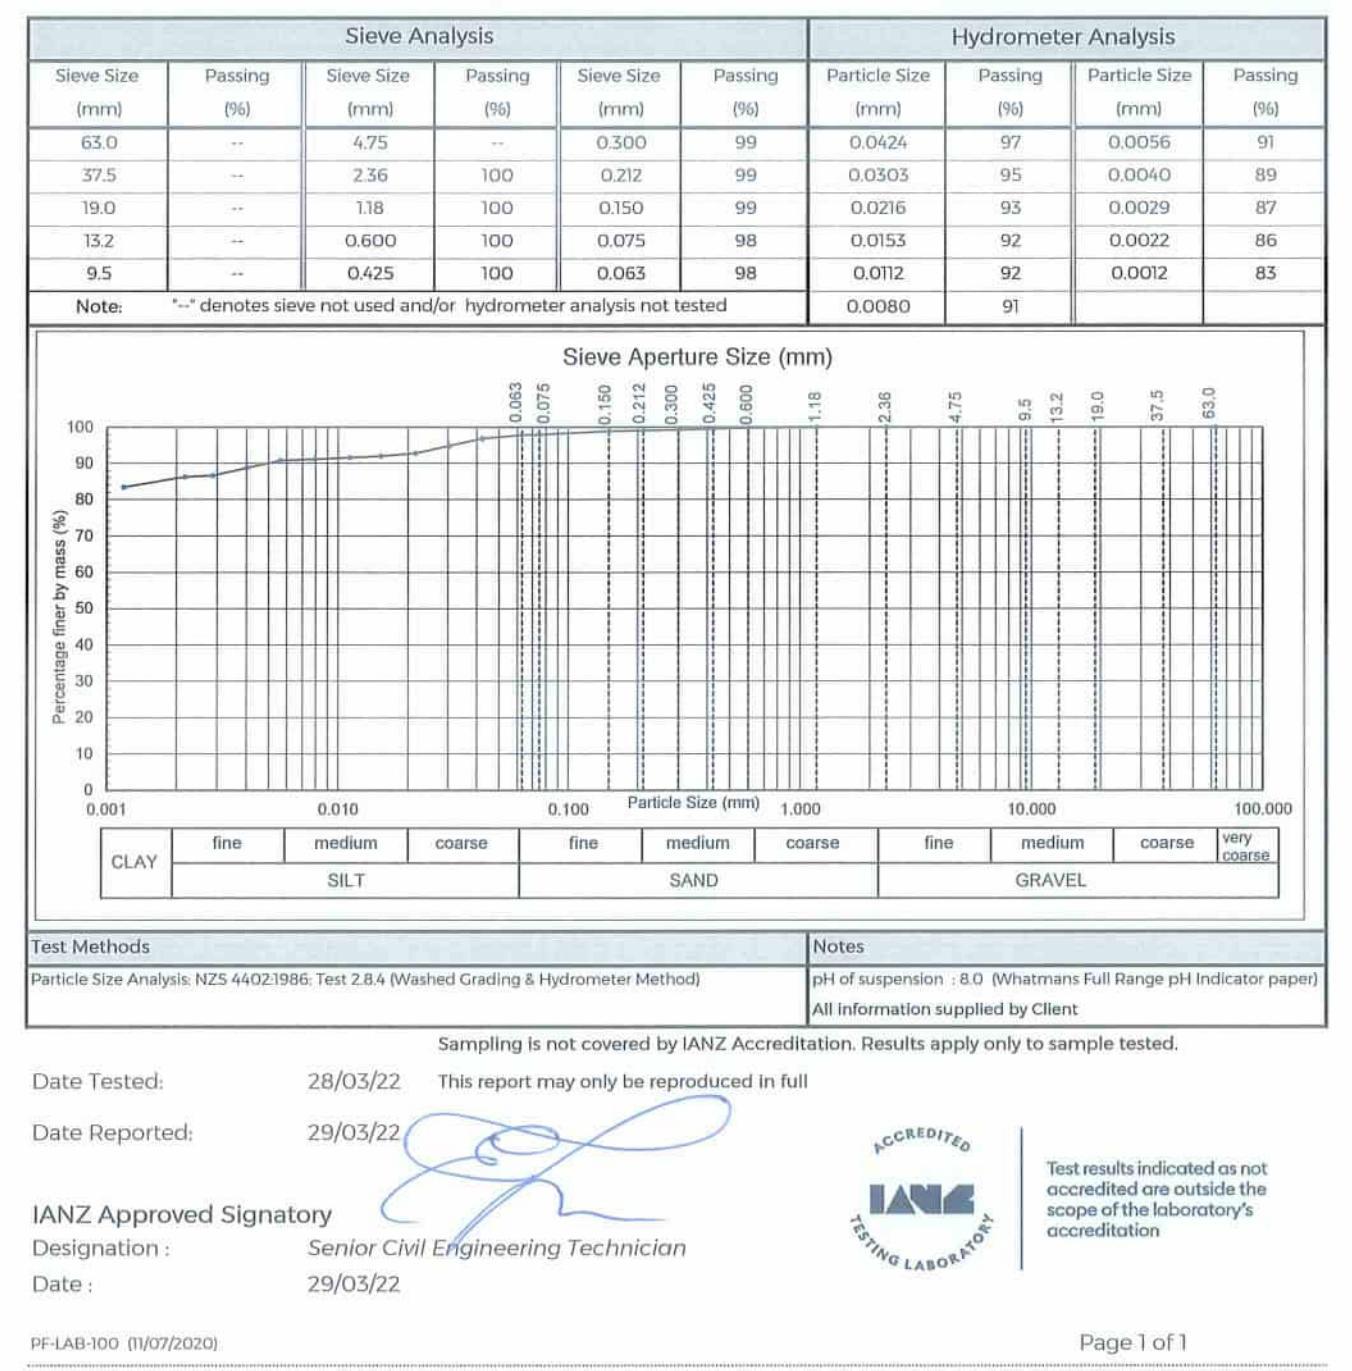
Project No:	2-68311.00	Î
succes and	HA8743/1 HYD	
Lab Ref No:		
Client Ref:	171738-LUK-SI

Project :	Greenhill Park Area LUK
Location :	Greenhill Park Area LUK EW.S2
Client :	Chedworth Properties c/o CORE50 Ltd
Contractor :	ONLINE Contractors
Sample Ref No:	#1
Sampled by :	Client (Aaron Kennedy)
Date sampled :	11/03/22
Sampling method :	Bulk Sample
Sample condition :	As received
Sample description :	CLAY, some silt, trace sand
Solid Particle Density (t/r	n ³): 2.66 Tested
Water Content (as receiv	ved): 55.7 %

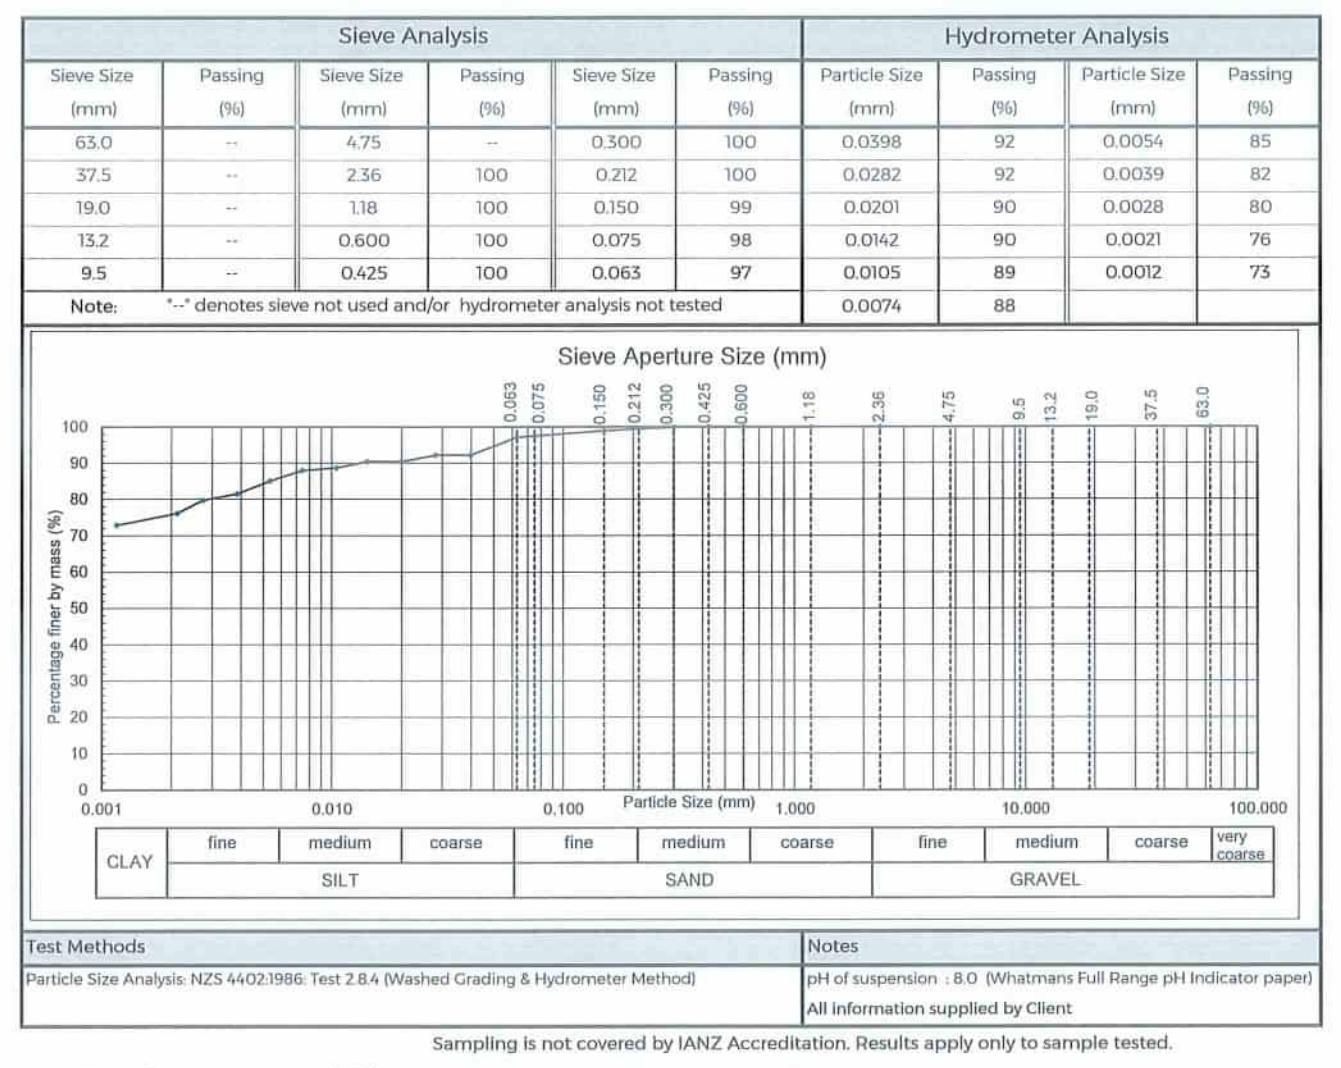
Project No:	2-68311.00
Lab Ref No:	HA8743/2_HYD
Client Ref:	171738-LUK-SI

Project :	Greenhill Par	rk Area Ll	JK		
Location :	Greenhill Park Area LUK EW.S2				
Client :	Chedworth F	Properties	s c/o CORE50 Ltd		
Contractor :	ONLINE Con	tractors			
Sample Ref No:	#2				
Sampled by :	Client (Aaron Kennedy)				
Date sampled :	11/03/22				
Sampling method :	Bulk Sample				
Sample condition :	As received				
Sample description :	Silty CLAY, tr	ace sand			
Solid Particle Density (t/m	n ³):	2.74	Tested		
Water Content (as receiv	ed):	62.0	96

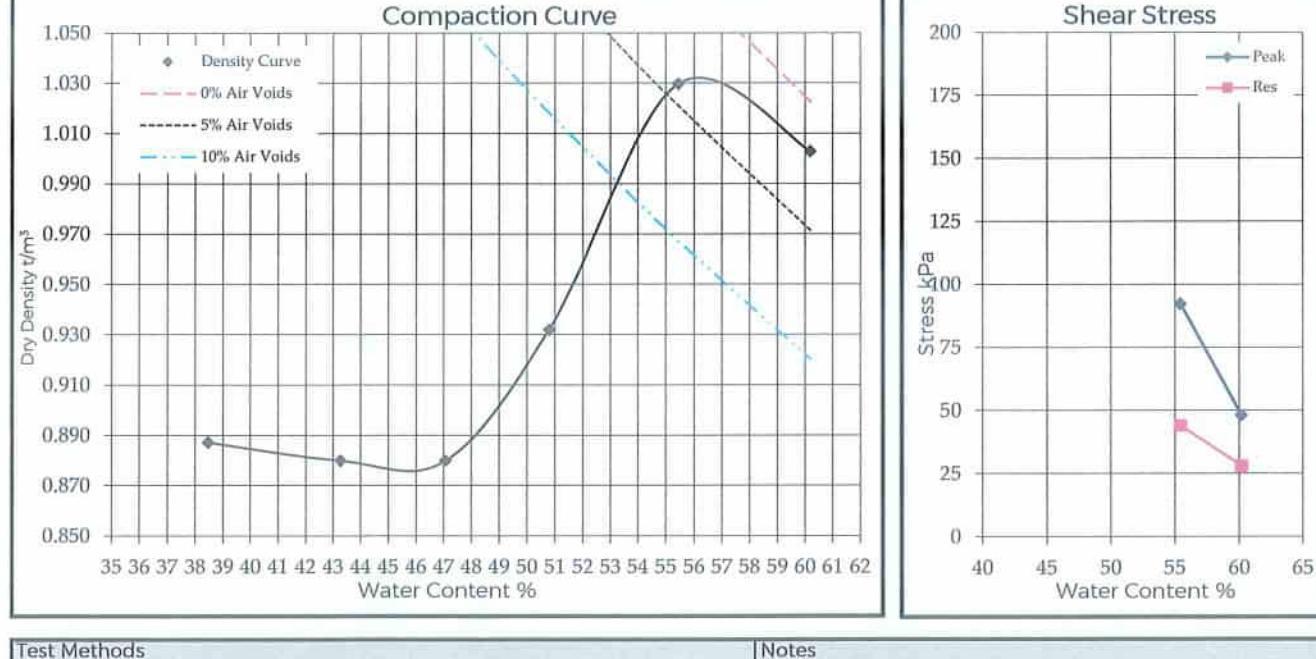
Test Results	5		1.2	
Maximum dry de	nsity	1.03	t/m³		Natural wat	ter content	55.4	%
Optimum water o	content	56	%		Fraction tes	sted 100	% Passing 1	9mm
Sample ID		-240	-180	-120	-60	Nat	60	
Bulk density	t/m³	1.228	1.261	1.294	1.405	1.601	1.606	
Water content	%	38.5	43.3	47.1	50.8	55.4	60.2	
	1 1	0.000	0000		0.070	1.070	7.0.07

Tracer correction	1.0	0010	10110		~ ~ ~ ~			
Dry density	t/m³	0.887	0.880	0.880	0.932	1.030	1.003	
Sample conditior	ו	Hard Moist	Hard Moist	Hard Moist	Hard Moist-Wet	V. Stiff Wet	Stiff Wet	
Peak stress	kPa	UTP	UTP	UTP	>209	92	48	
Remoulded stres	s kPa	20	<u> 1</u>	2		44	28

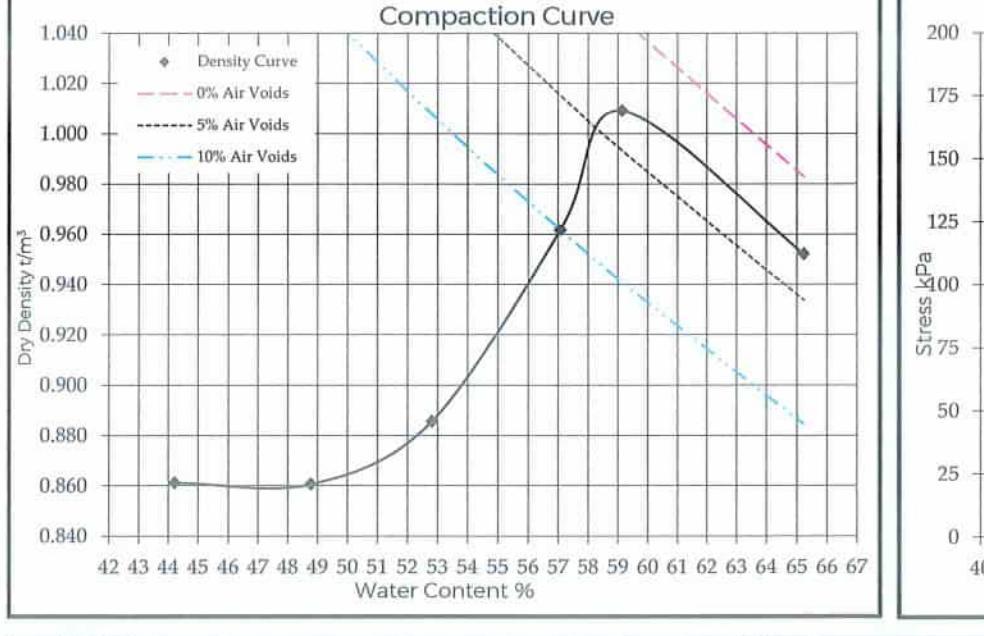
Tes	t Results			
Maximum dry density	1.01	t/m³	Natural water conte	nt	59.1	%
Optimum water content	59	%	Fraction tested	100%	Passing 1	9mm

Sample ID		-240	-180	-120	-60	Nat	60	
Bulk density	t/m³	1.242	1.280	1.353	1.511	1.606	1.573	
Water content	%	44.2	48.8	52.8	57.1	59.1	65.2	
Dry density	t/m³	0.861	0.861	0.886	0.962	1.009	0.952	
Sample condition	1	Hard	Hard	Hard	Hard	V. Stiff	Firm	
		Moist	Moist	Moist	Moist-Wet	Wet	Wet	
Peak stress	kPa	UTP	UTP	UTP	>209	88	44	
Remoulded stress	s kPa	200		-	-	40	16

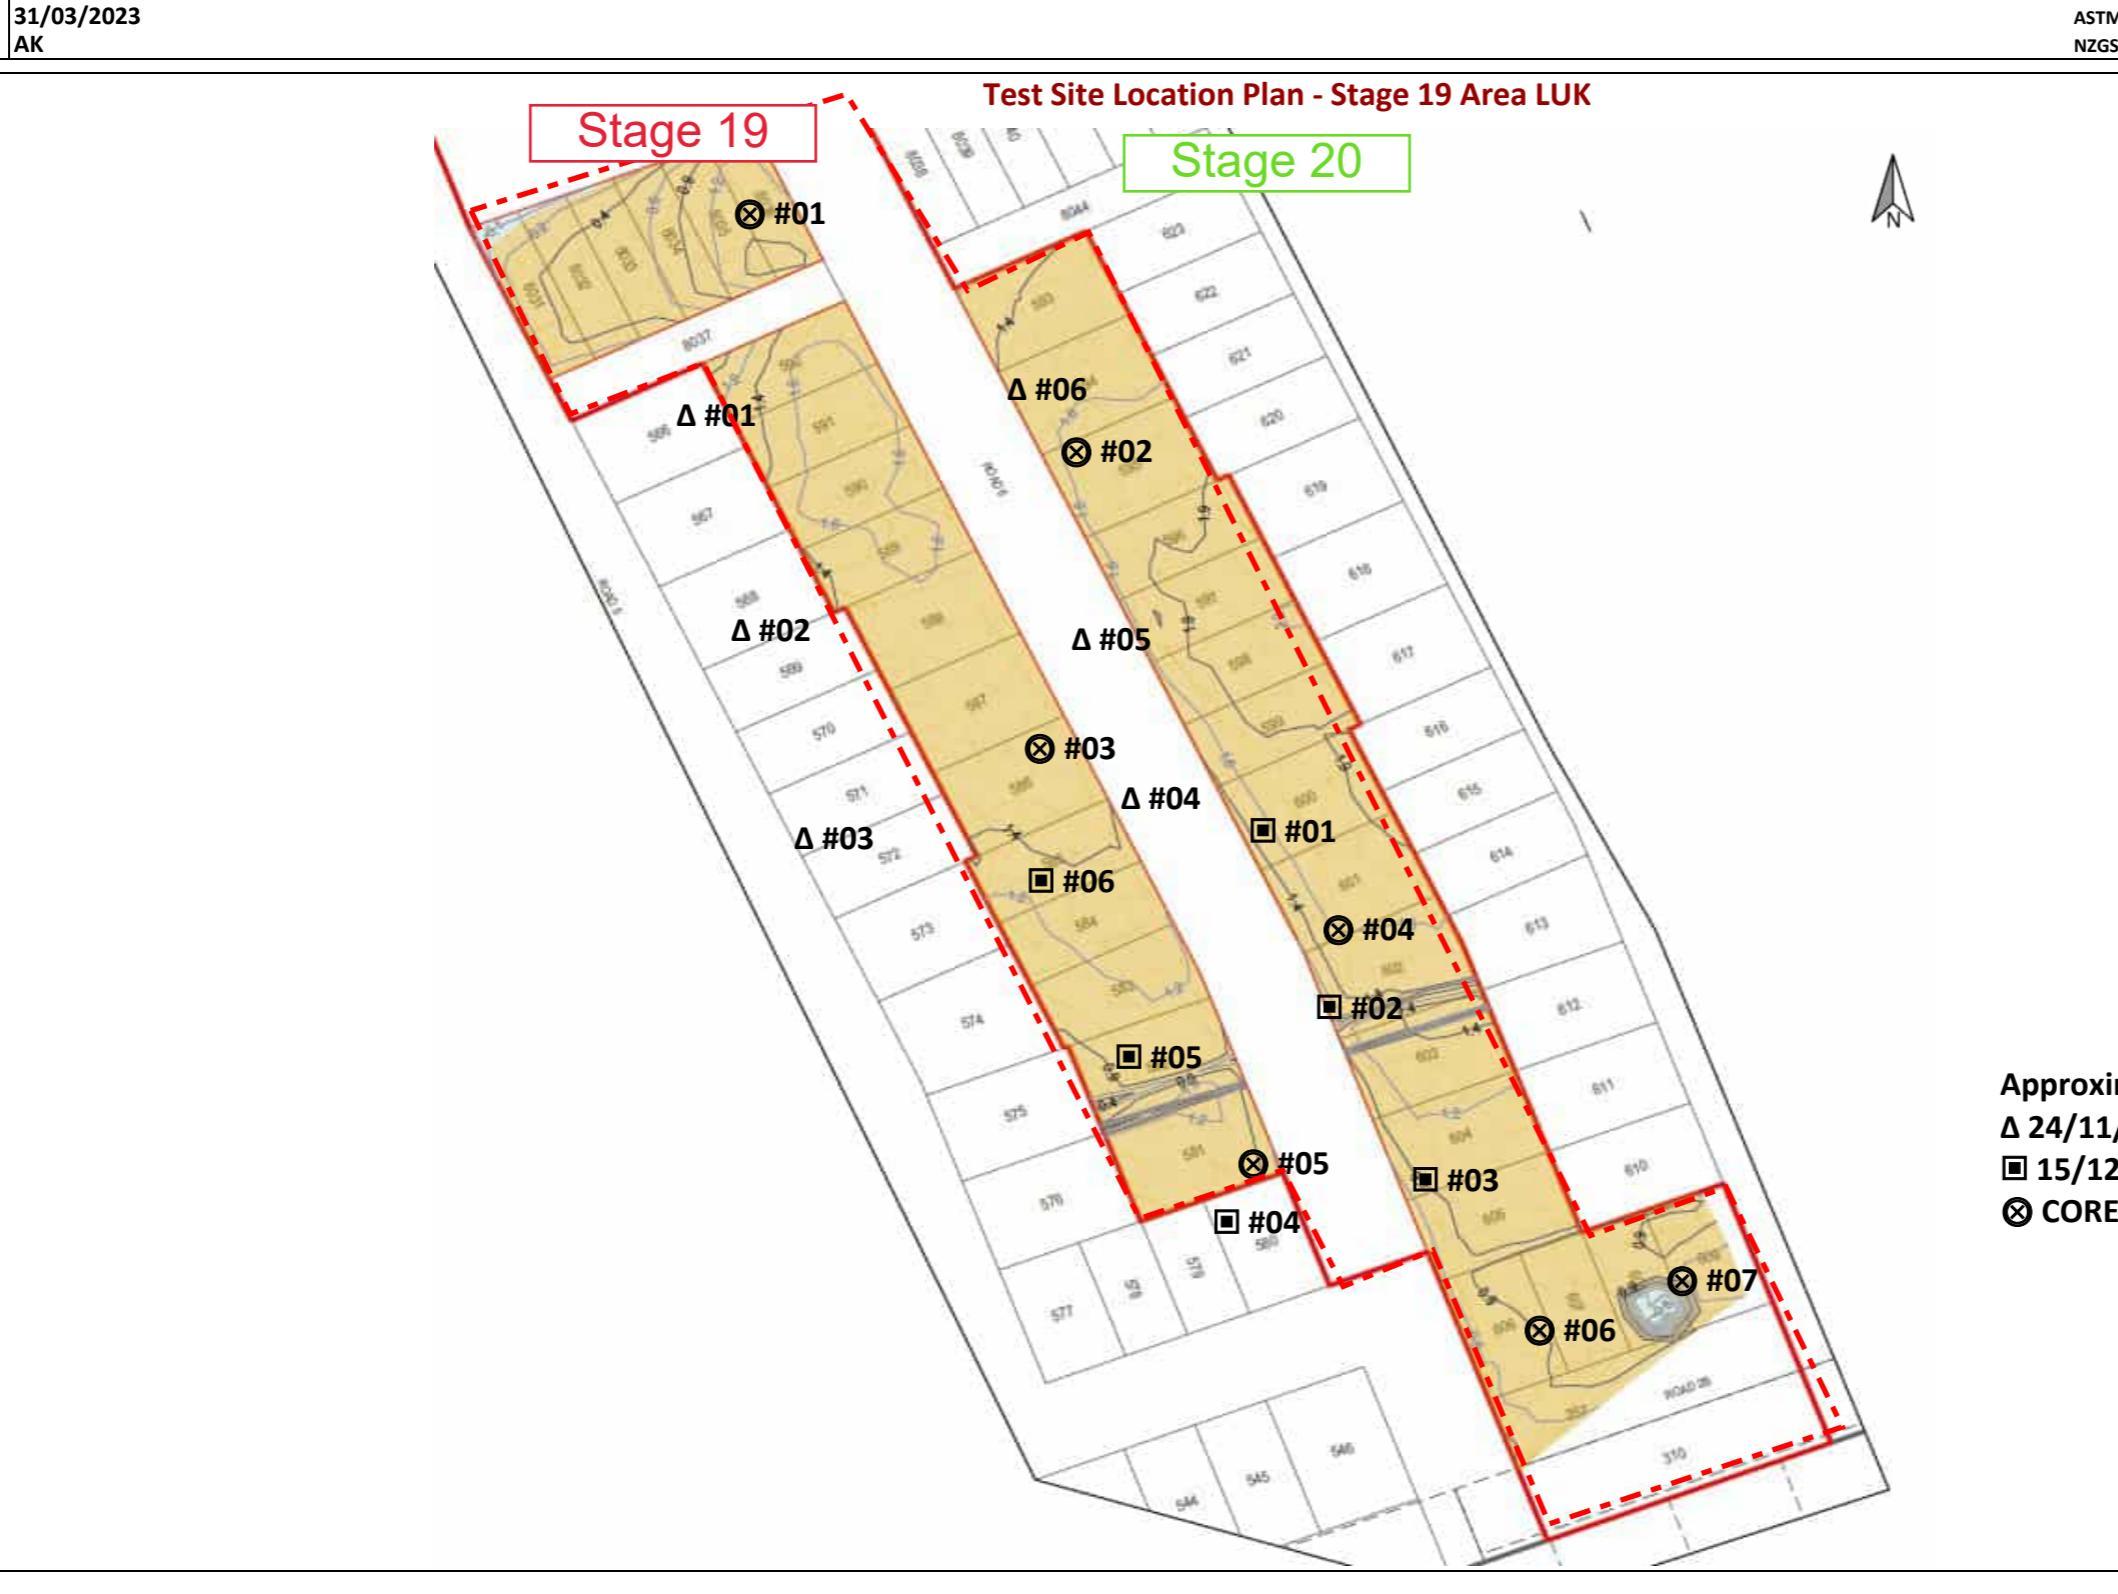
E50 Ltd	
nilton Office:	62 Church Road, Pukete, Hamilton, 3200
po Office:	89 Tahara Road, Taupo, 3330
ne:	0800 CORE50
) :	Core50.nz
t Methods:	Notes:
6 4402 1986 Test 2.1	Water Content done by External Laboratory
6 4407 2015 Test 4.2	NDM Direct Transmission
6 4407 2015 Test 4.3	NDM Back Scatter
ANZ TG1 2011	Scala Dynamic Cone Penetrometer
M D5874 - 16 2007	Clegg Hammer
GS: August 2001	Hand Held Shear Vane

Approximate Locations:
Δ 24/11/202: Schick Testing
■ 15/12/2020: Coffey Testing
⊗ CORE50 Testing.

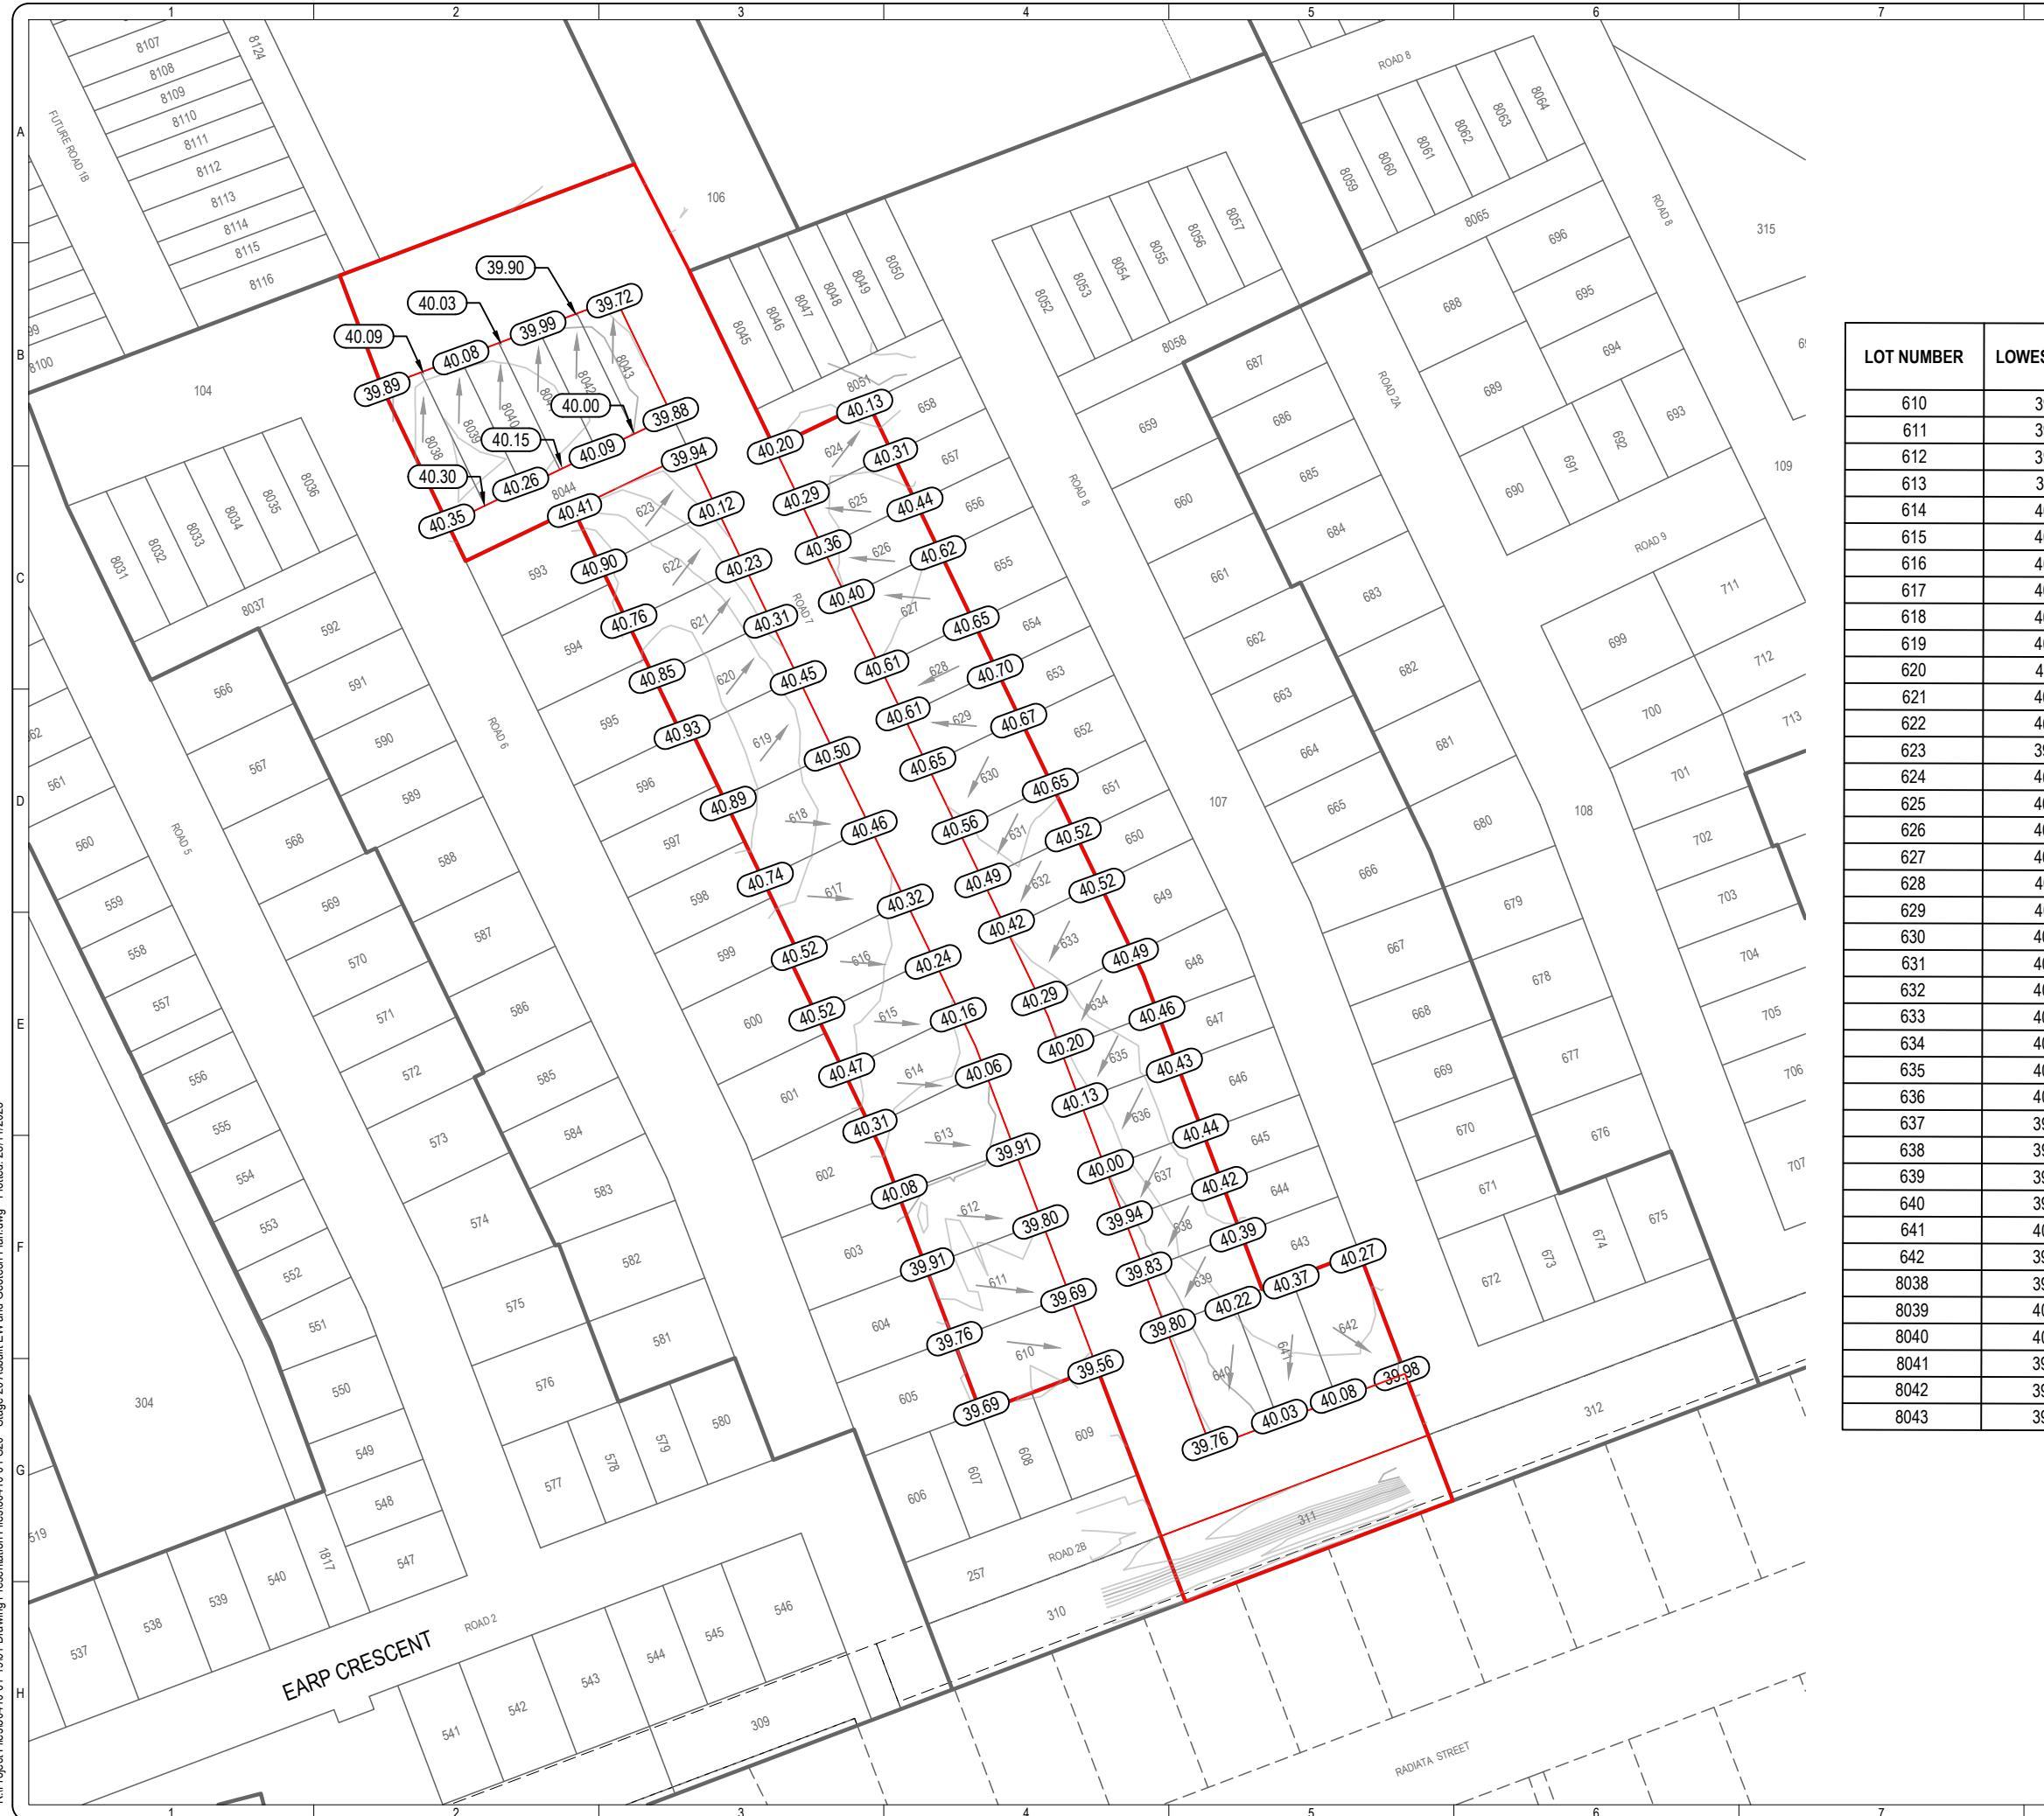
Appendix E <u>Stormwater Management</u> Minimum Lot Levels: 30410-01-S20-G1 Rev. AB2

-								_
8			(s	<u>ک</u>)		
►NN	A		S & L	Land	Spee	cial	ists	\$
			Fn	Ph. 07 5 nail: info@				
				ox 231, T www.sll	aurang	a 314		
		LE	GEND:					
MINIMUM			(38.2)		ot Hei /el*	ght (Grou	ind
MINIMUM INISHED FLOOR	в		-	-	vei ope Ari	row		
LEVEL (FFL)								
<u>39.71</u> 39.84				Ma	jor Co	ntol	ır

39.95		_		Mir	nor Co	ontou	Jr	
40.06								
40.21								
40.31								
40.39	с		nto		00			
40.47			ntour Inte	rvai = (J.20m			
40.60								
40.46		*Gi	round Lev	els are	NOT	to b	e us	ed

- iv. All lots need to observe minimum floor levels and require surface falls from the rear of the lot to the front.
- 4.0 This professional opinion is furnished to Hamilton City Council and the developer for their purposes alone on the express condition that it will not be relied upon by any other person and does not remove the necessity for the normal inspection of foundation conditions at the time of erection of any dwelling.
